SURFACE CHARACTERISTICS OF ALUMINIUM FOIL

This catalogue was developed by the foil rollers organised in the European Aluminium Foil Association (EAFA) with the purpose to facilitate discussions between business partners. It describes the most common surface characteristics in more detail and is intended to provide common language for any potential discussion caused by potential visual surface characteristics on the aluminium foil.

June 2020

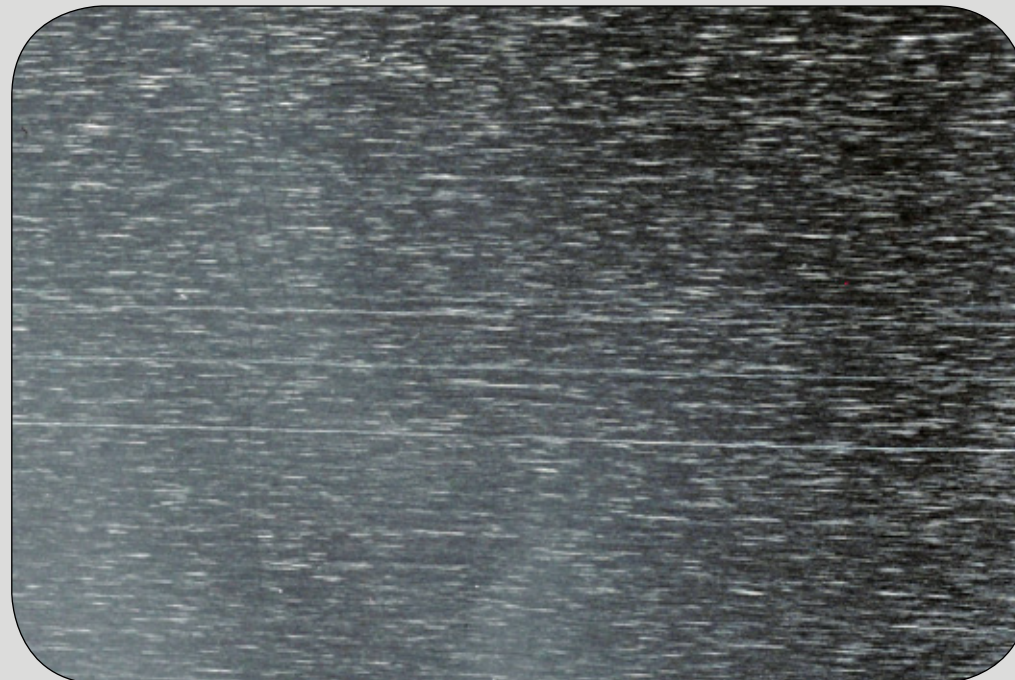
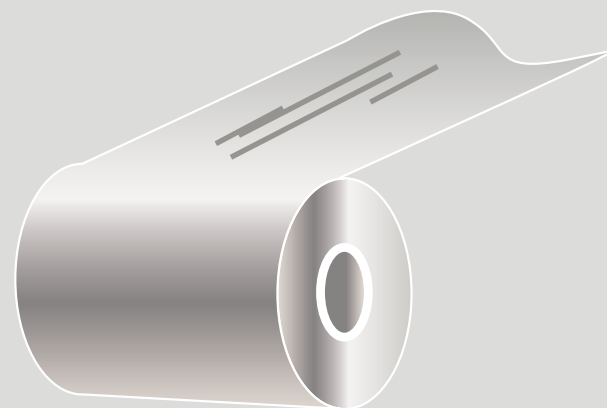
1 SCRATCHES

Mechanical damage to the aluminium surface in the form of sharp indentation. Can be periodically repeating with equidistant appearance or continuously or limited to certain area.

Mostly in machine direction but in isolated cases also in other directions:
Transverse scratch or „snowball“ (Scratch with material ejection, mainly in soft materials).

Transverse scratch („Snowball“)

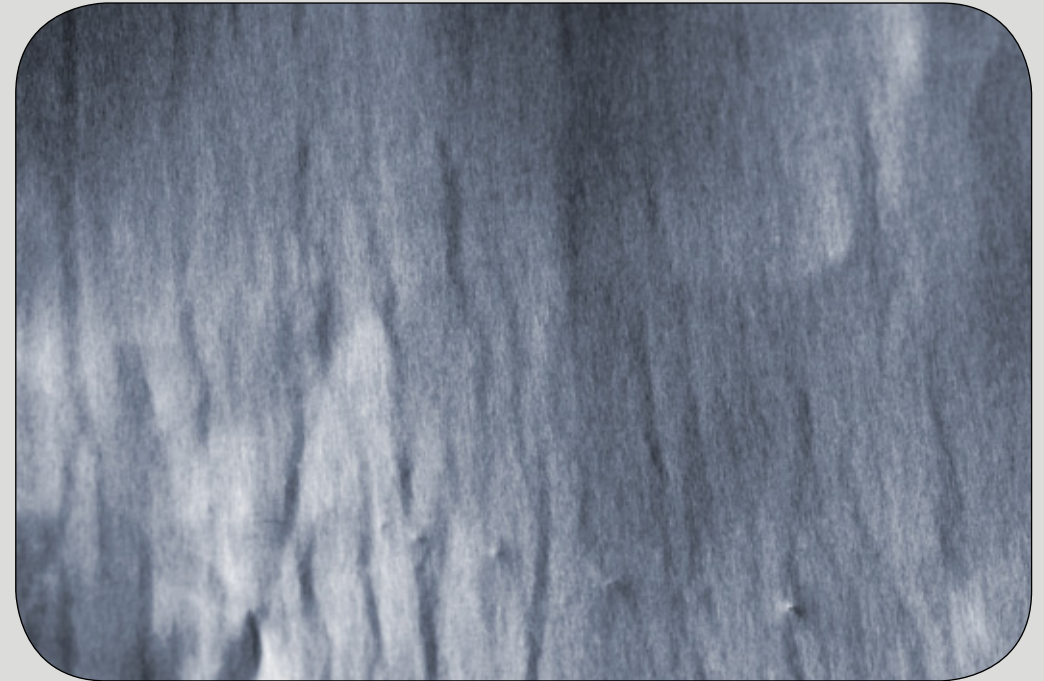
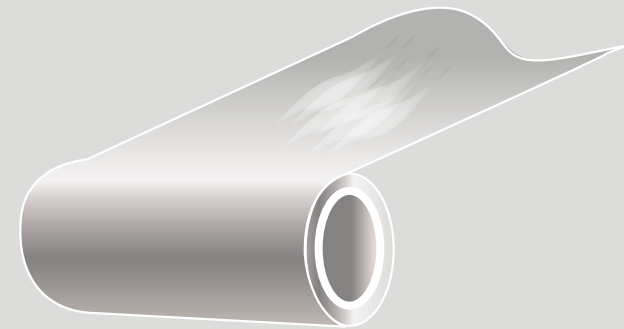
FRICTION MARKS

Randomly distributed mechanical damage in form of shallow modifications most likely to occur near the core.

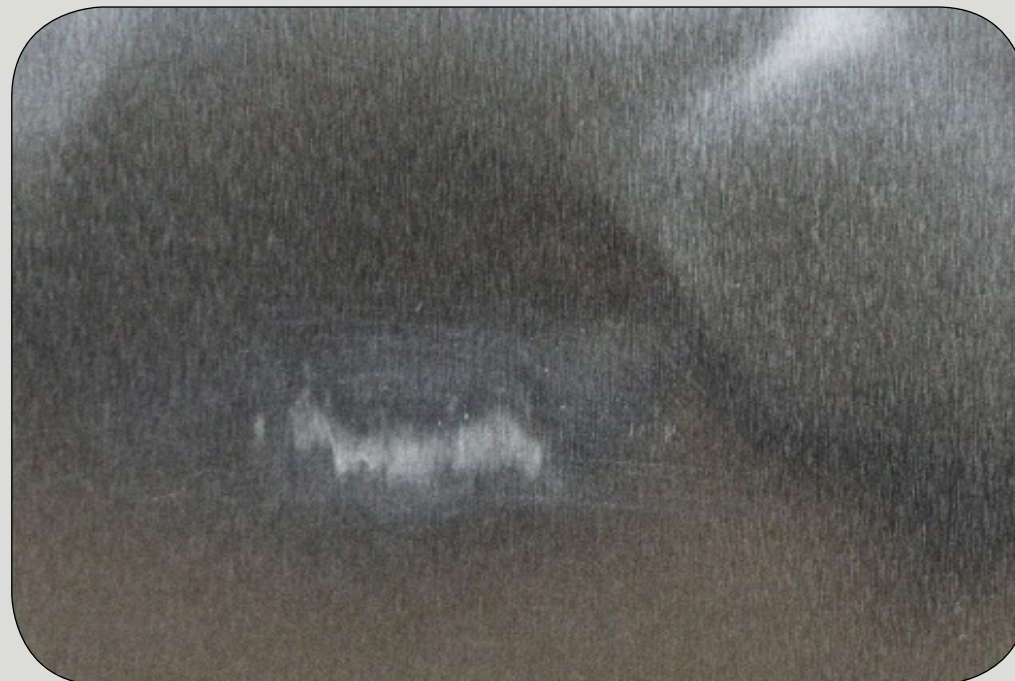
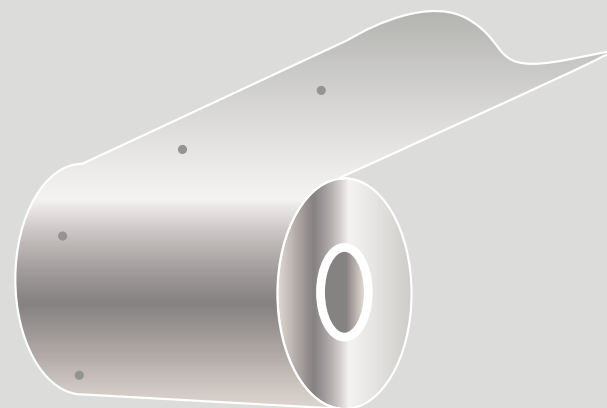
3 ROLL MARKS

Damage to the foil surface resulting from damage on the rolling equipment, e.g. on the work roll. Equidistantly recurring, corresponding with contact between damaged equipment and aluminium surface.

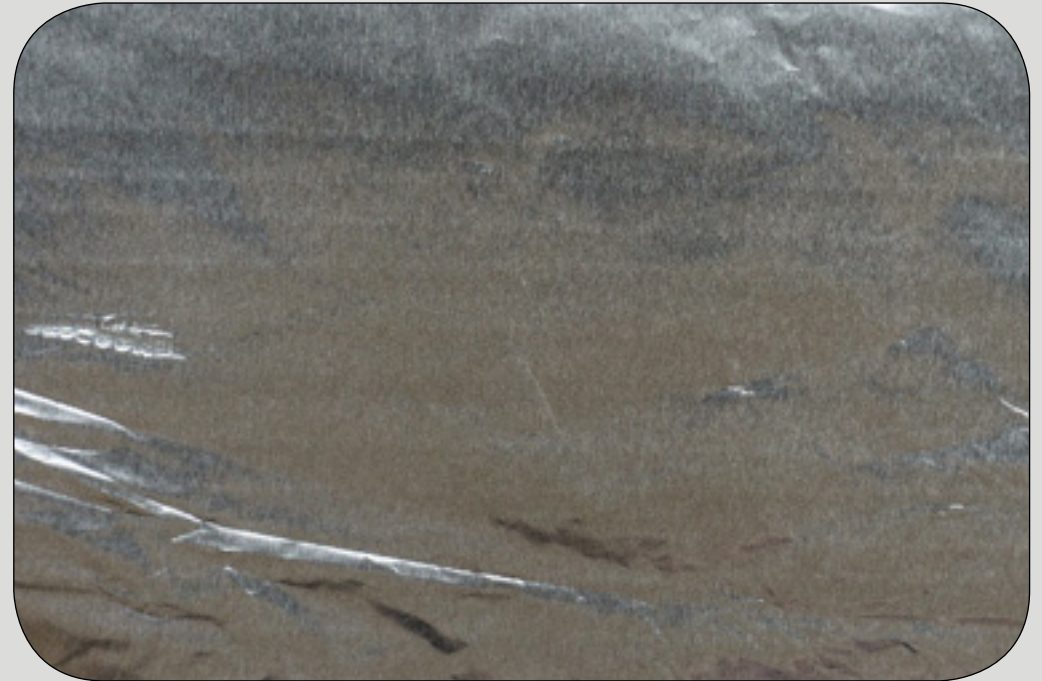
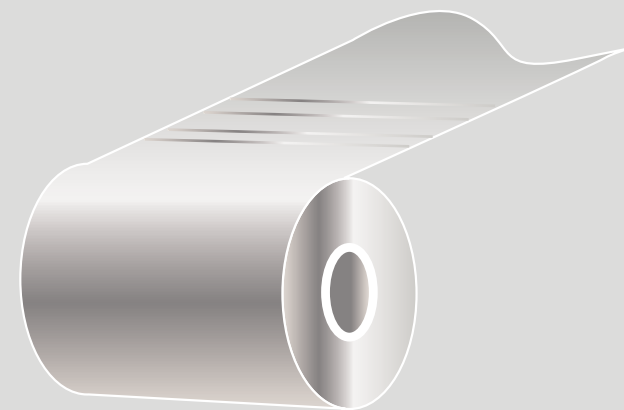
4 CHATTER MARKS

Intermittent lines perpendicular to the rolling direction.

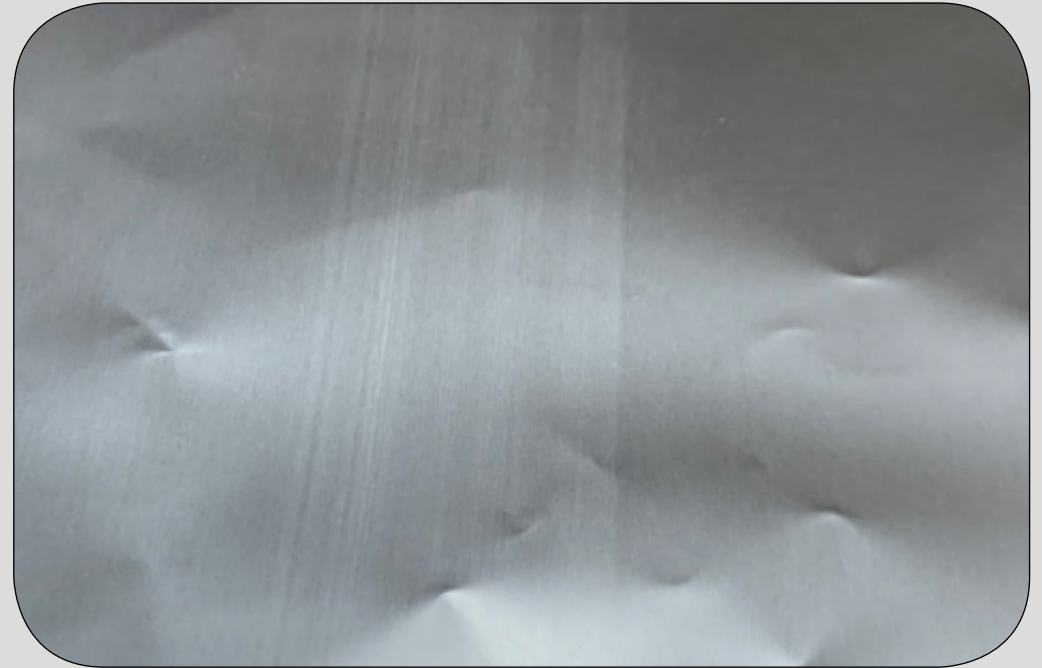
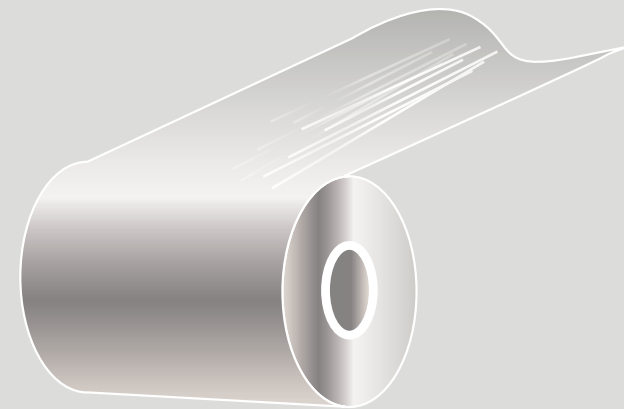
5 **STRIPES**

Purely visual, not causing thickness differences, can be present on one side or on both sides of the aluminium foil.

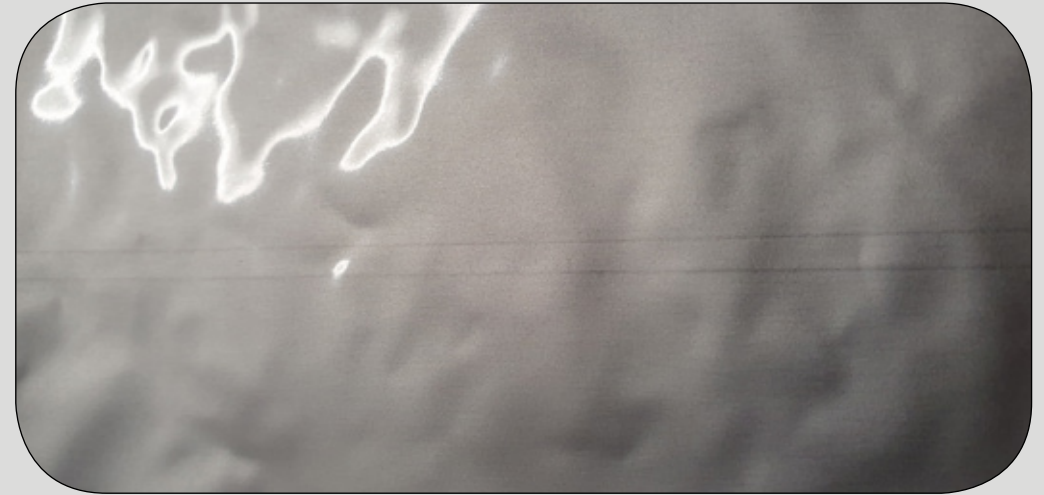
5.1 ROLLING STRIPES

On gloss side only, constant in rolling direction.

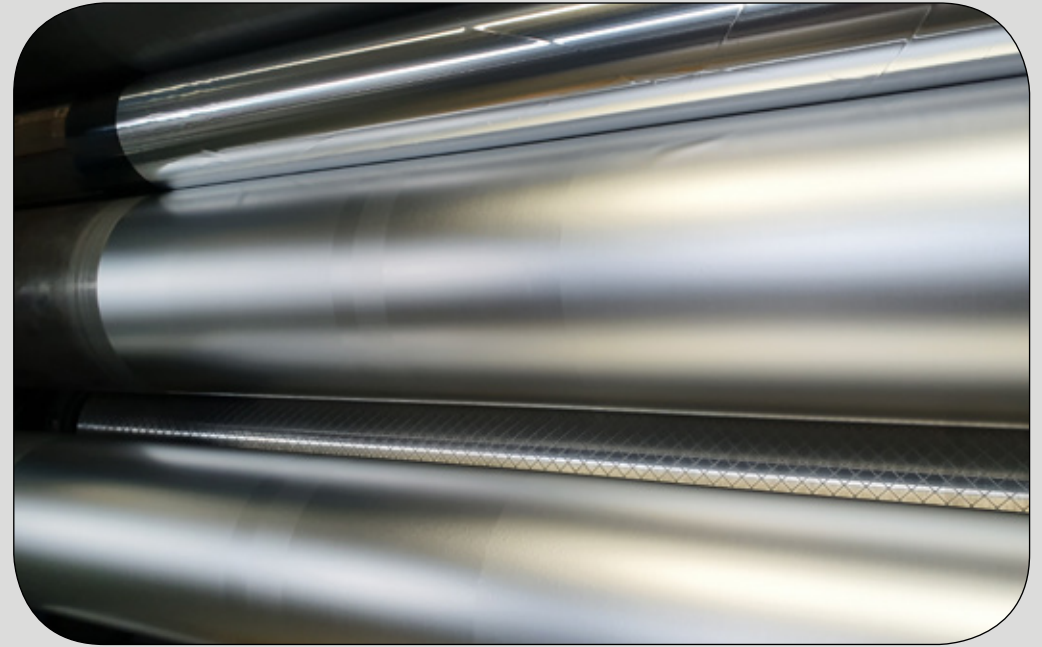
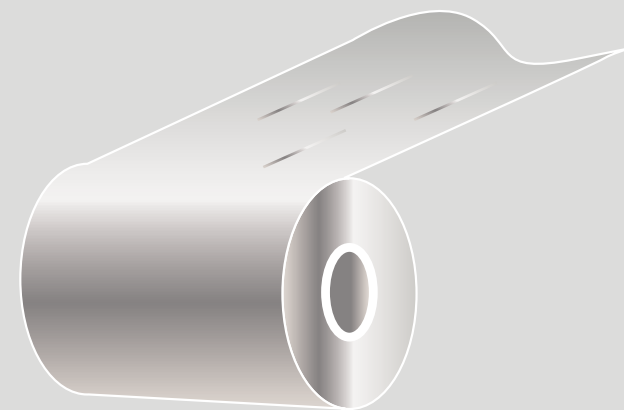
GLOSS DIFFERENCE

The material appears in – usually two – different kinds of glosses on the matt side only. Gloss difference does not appear on gloss-side; usually in rolling direction, due to rolling the aspect ratio can be very long.

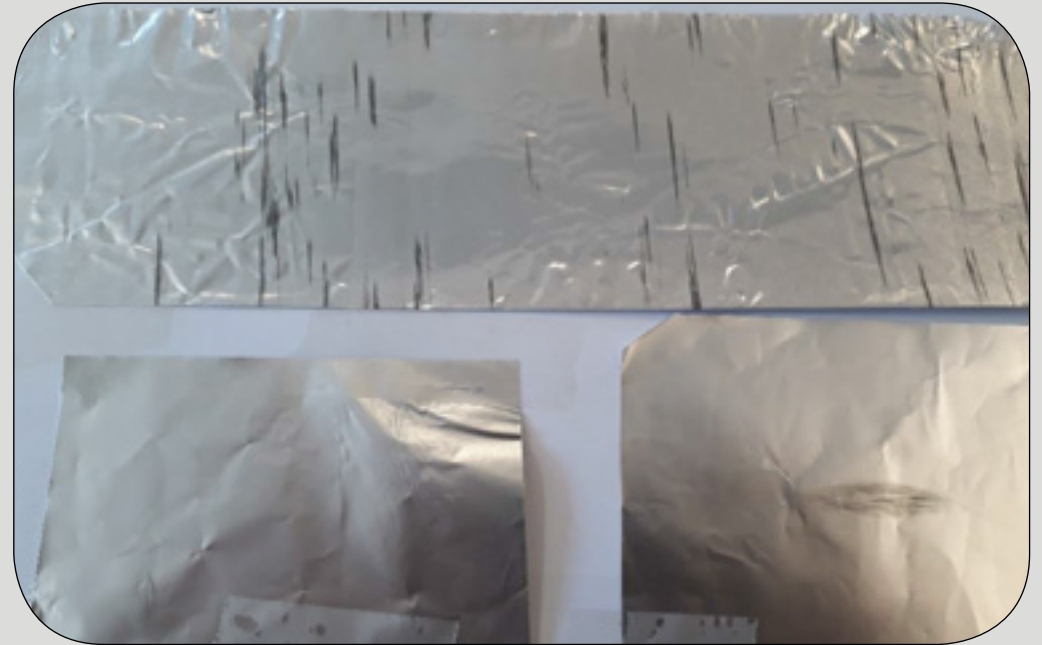
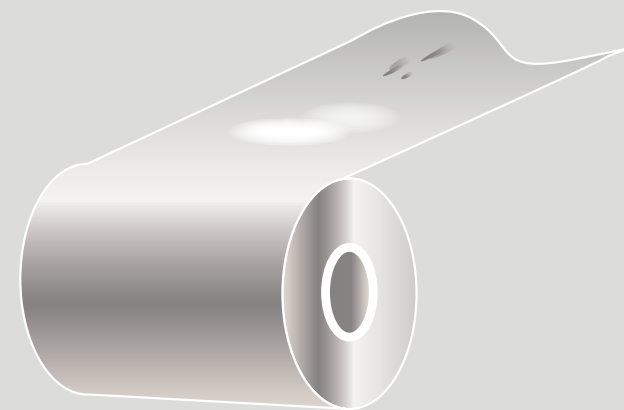
STAINS

Surface appears glossier in scattered areas, randomly distributed with light/dark contrast. Purely visual, not causing thickness differences.

During further rolling stains can become streaks.

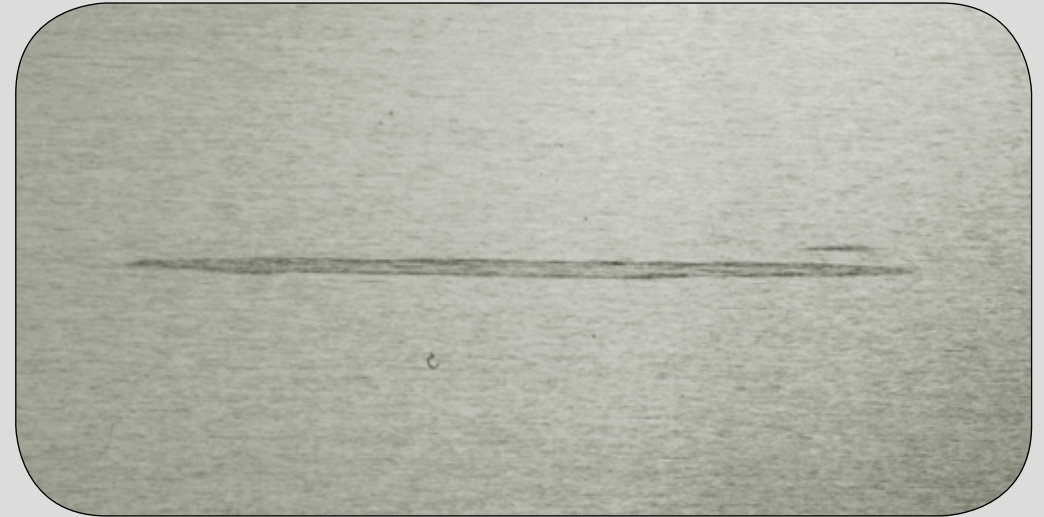
7.1 OIL STAINS

Brown stains usually on the edge of the foil.

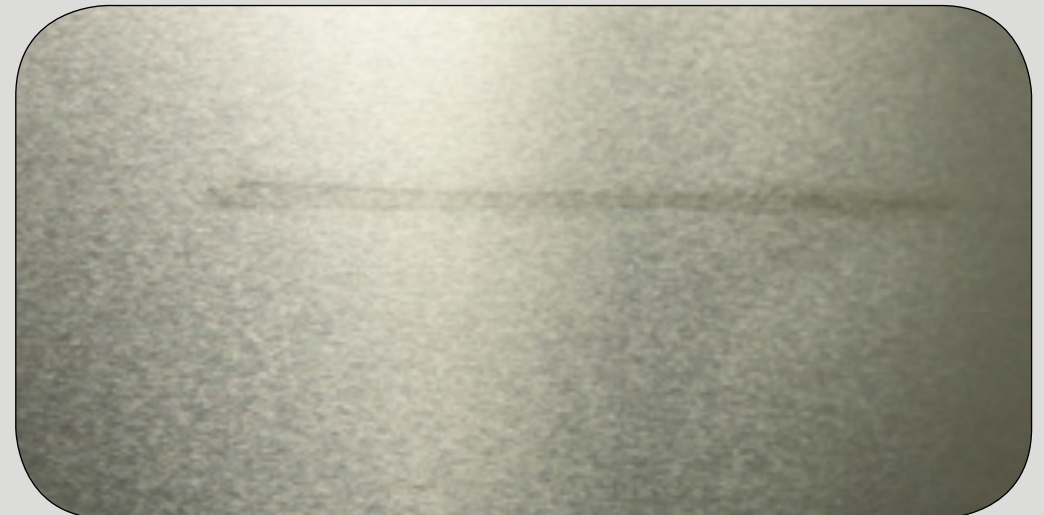
7.2 DIRT STAINS

Stains randomly distributed on the surface of the aluminium foil.

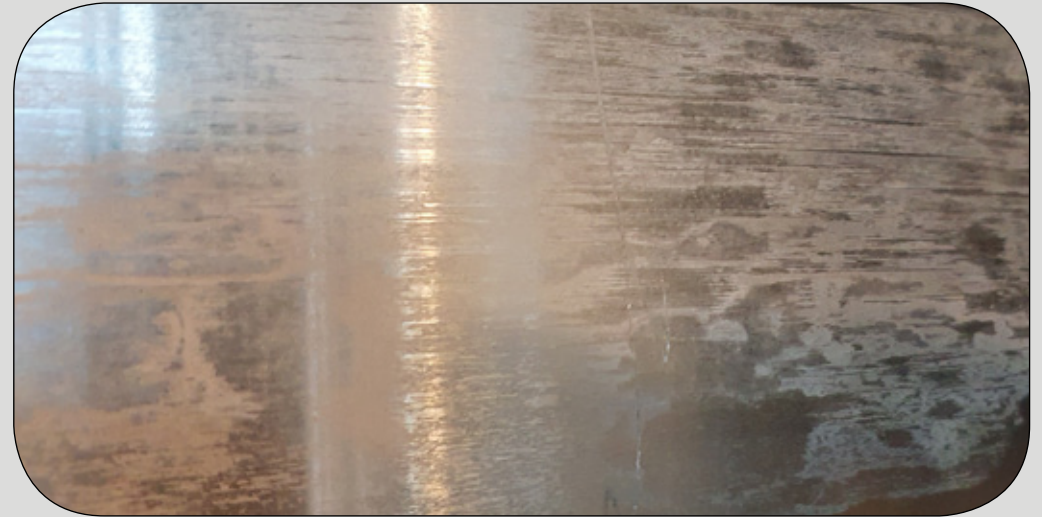
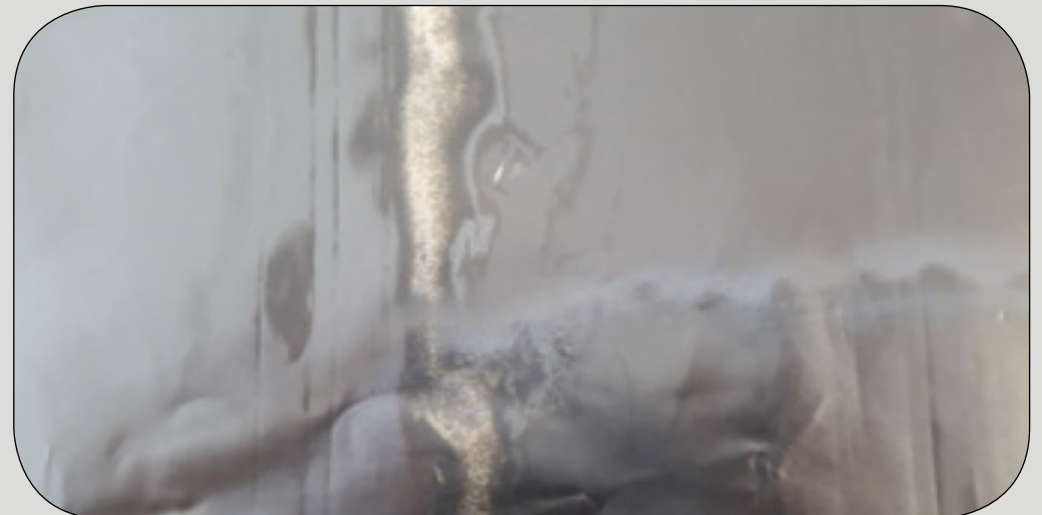
7.3 WATER STAINS

White stains, randomly distributed on the aluminium foil, depending in touch with water.

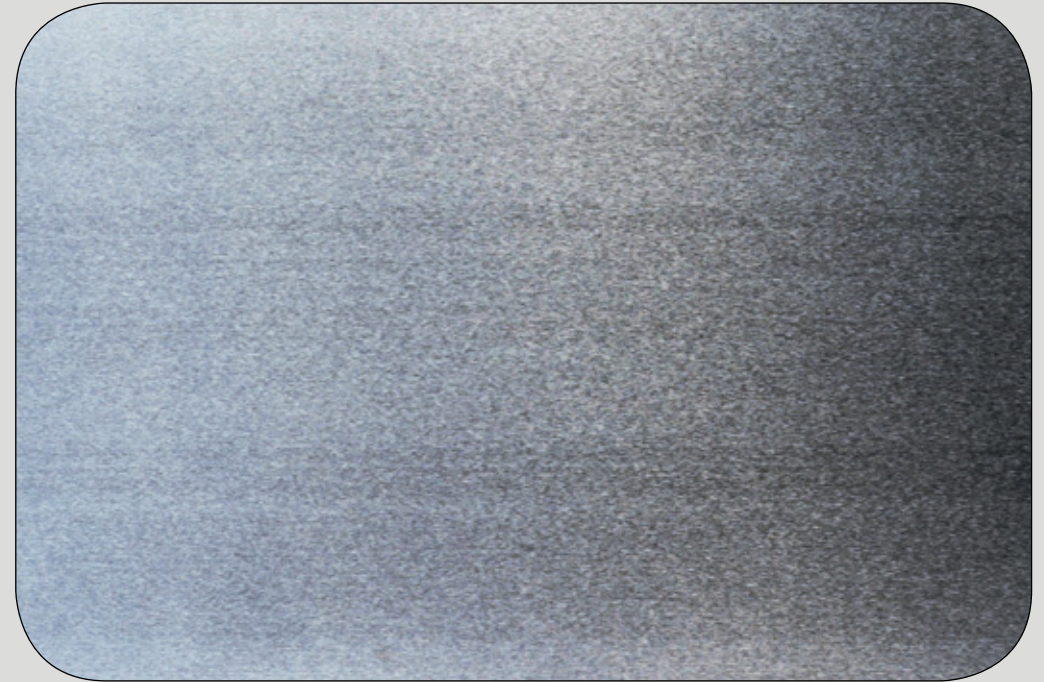
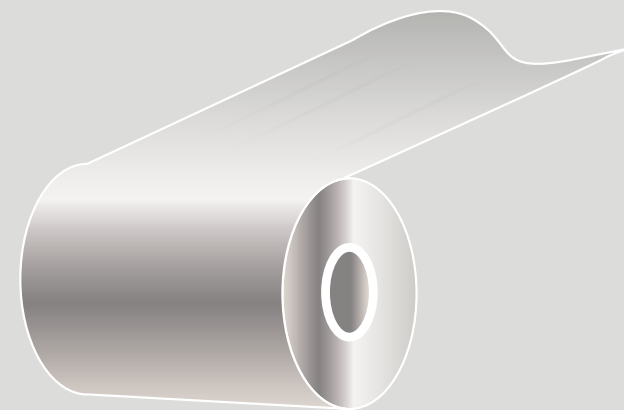
8 STREAKS

Mostly dark areas on the foil with elongated – stretched-appearance (high length/width-ratio).

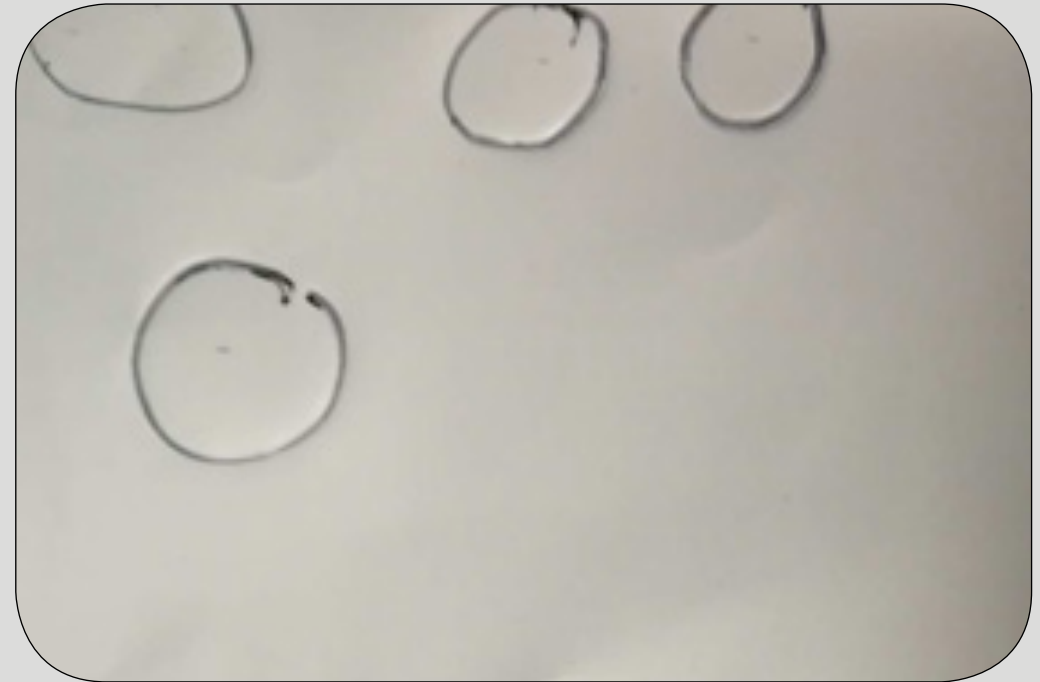
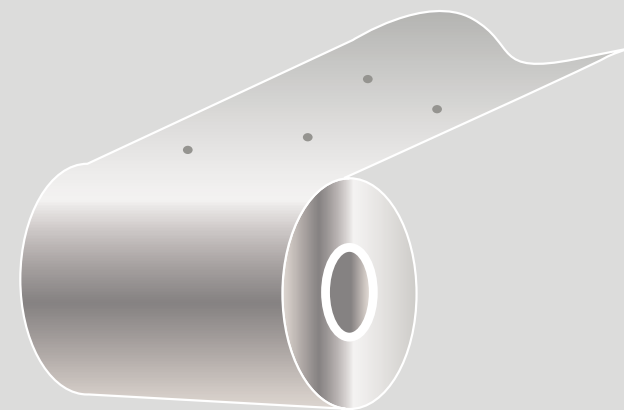
9.1. BLACK SPOTS

Black spots randomly distributed on the surface of the aluminium foil.

- Small particles of aluminium and aluminium oxide generated by abrasion in the machine and subsequently transferred to the surface.

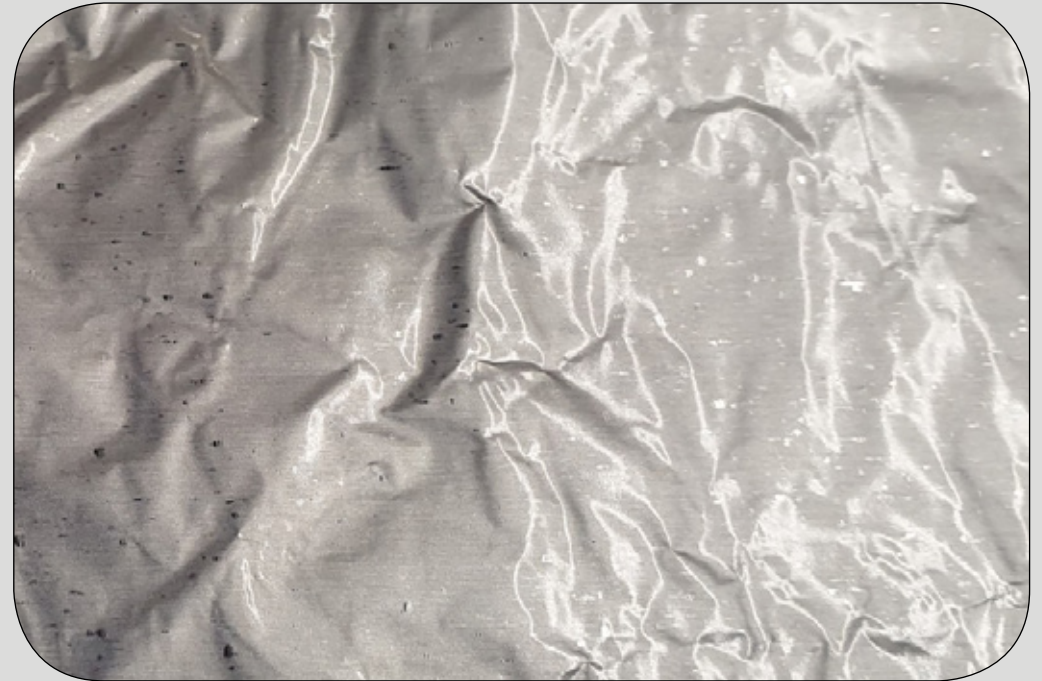
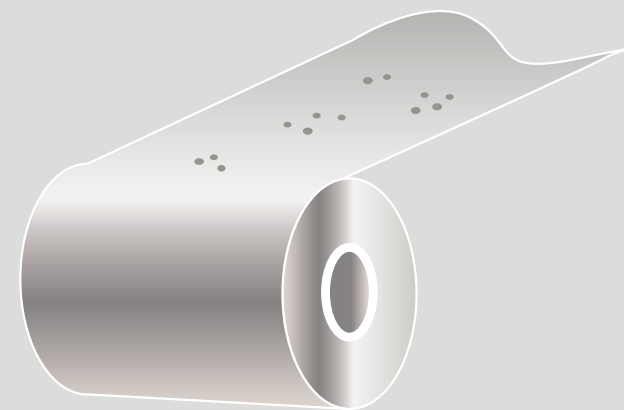
BROKEN MATTS

Bright spots on matt side of mechanical origin, only visible in double foil at last pass, of mechanical origin.

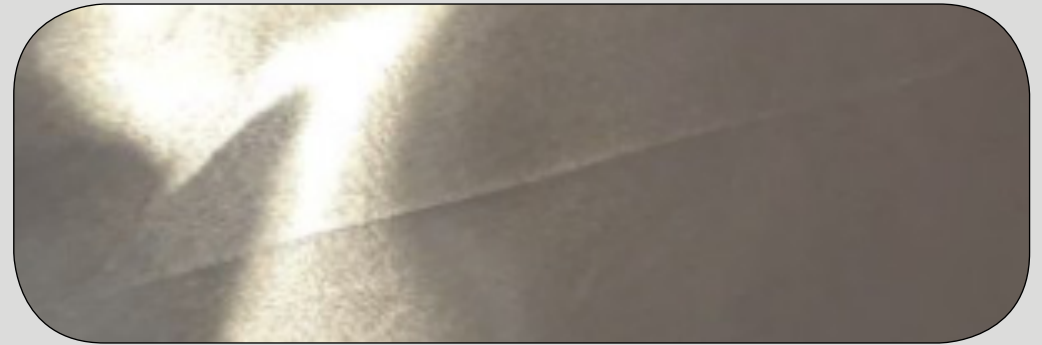
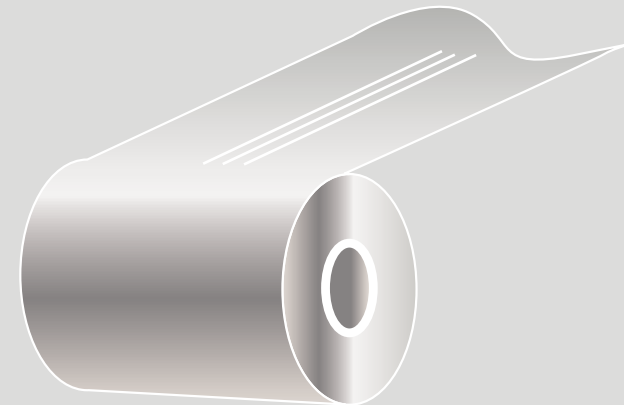
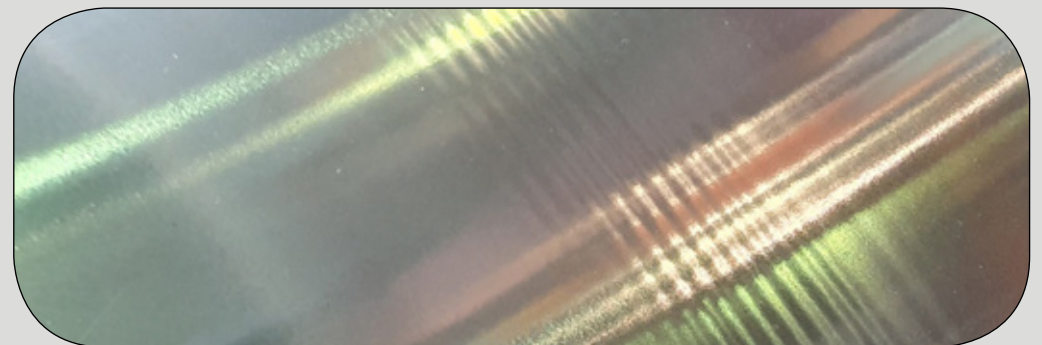
GROOVES

Grooves can result in different patterns on the finished foil reel, esp. <10mic – example “Seilfalten” (commonly visible on reel only)
